Home Inspection Tennessee LLC

Property Inspection Report

Date of Inspection: 12/13/2017 Time: 10AM

Age of Home: 9 years

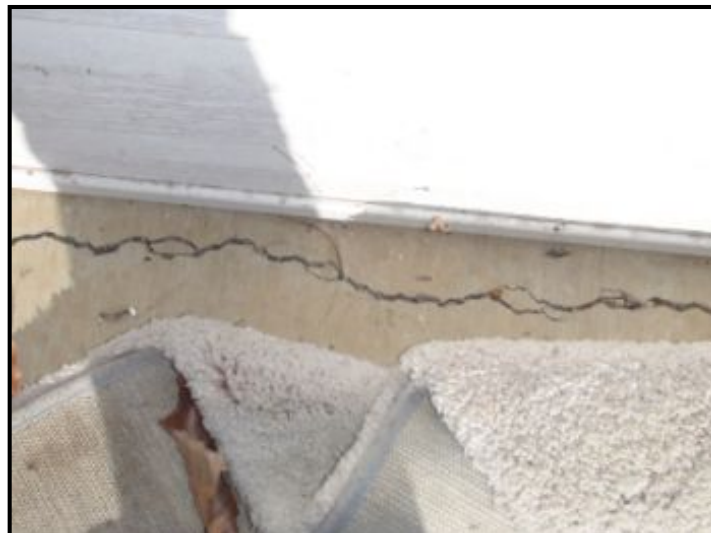
- Inspected: YES
- Concrete Slab
- There are minor cracks in the concrete slab present

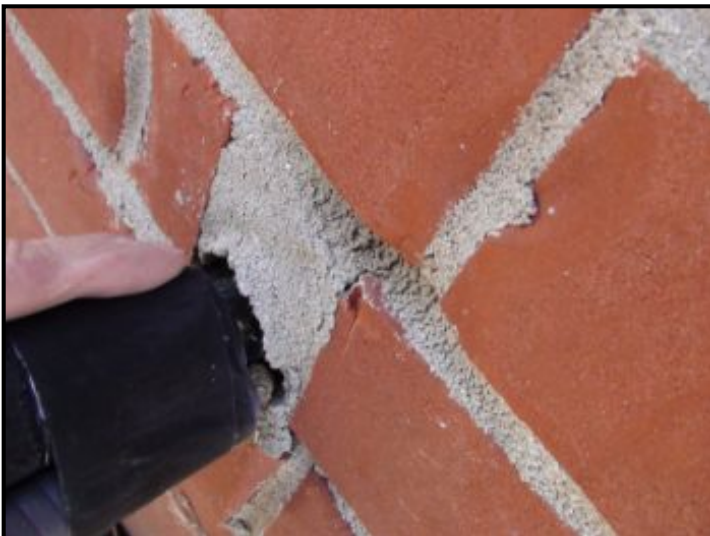
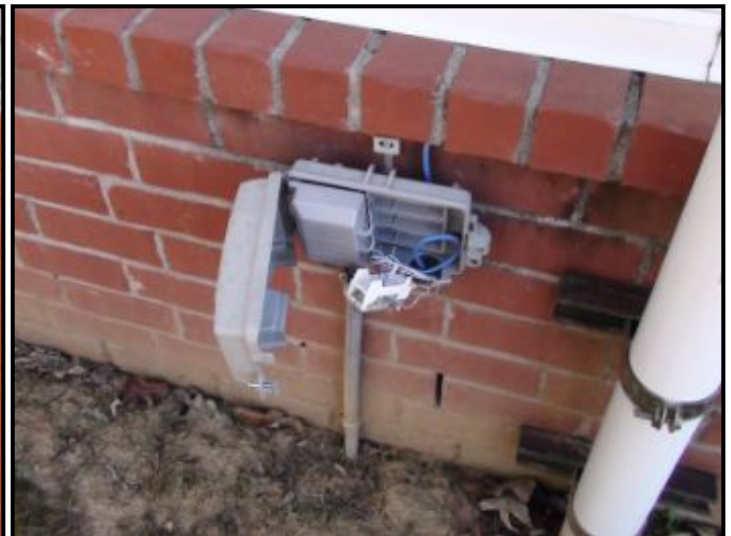
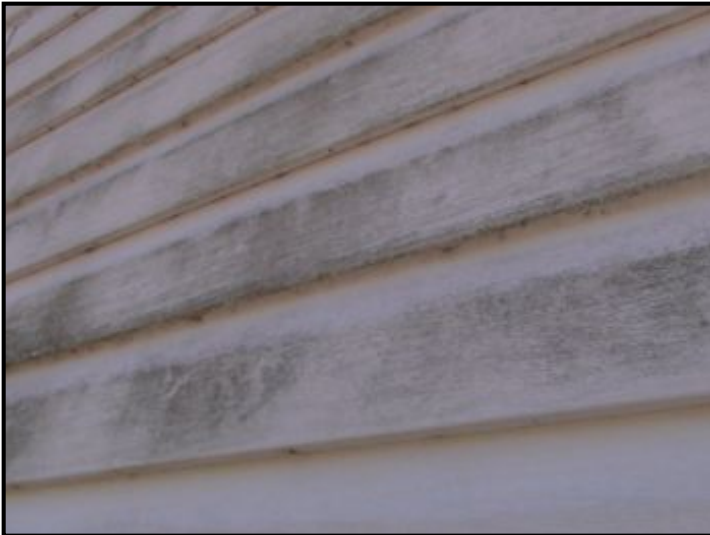
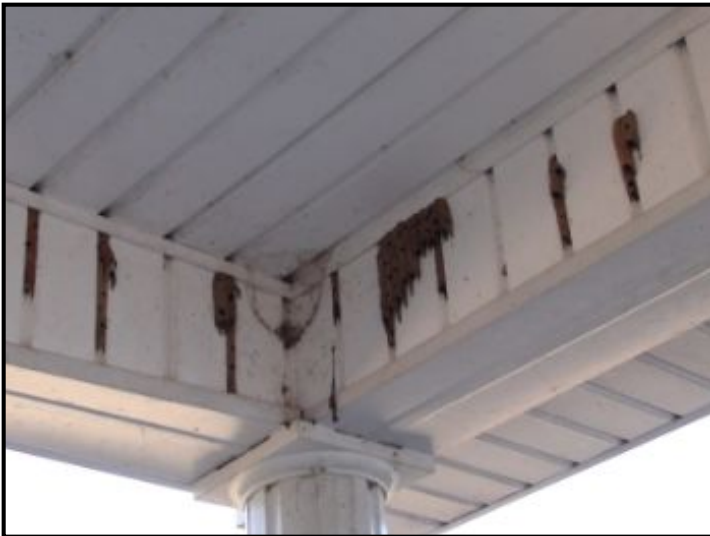
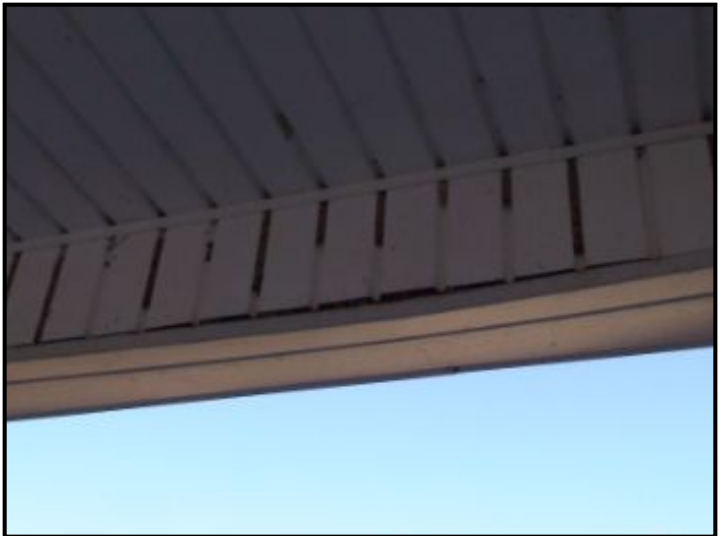
- Inspection limited due to vegetation
- Vinyl siding damage. Recommend repair or replacement of damaged sections to keep moisture and insects from harming structure.
- Some flashing at the gable end entrance section needs to be re-fastened.
- All openings and penetrations of the siding and wall should be closed with cement or caulk. The AC lines should be insulation continuously through the wall to prevent condensation within the wall structure
- The connecting box of the phone line should be closed
- The siding on the north side should be cleaned and the remainders of the wasp nests underneath the north side front porch should be removed
- Comment: There is a small hole in the siding on the North side

Most of the windows were difficult to operate; a possible reason for this could be the low temperature, but I would recommend to have them evaluated and serviced by a qualified contractor. The exterior siding on the north side shows a small hole. This should be closed immediately to avoid possible water infiltration. In addition - all openings in the exterior walls should be sealed carefully.

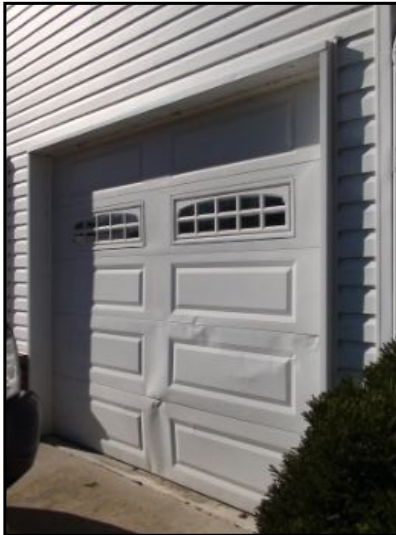
- Inspected: YES
 - Operated: YES
 - Roll-up door
- Observations:
- dented

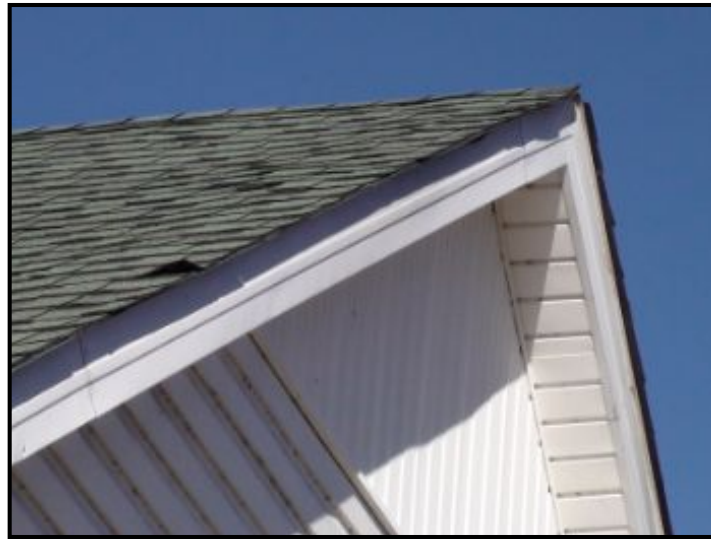
- Inspected: YES
- Inspected from Ladder, due pitch and weather conditions (this inspection is limited).
- Material:
 - Asphalt shingles
- Observations:
 - Appeared serviceable at time of inspection
 - No major system safety or function concerns noted at time of inspection.
 - Siding-Roof Contact: Recommend a 1" gap between the siding and the roofing below where necessary.
 - Comment: The end of one roof shingle is loose above the garage gable end

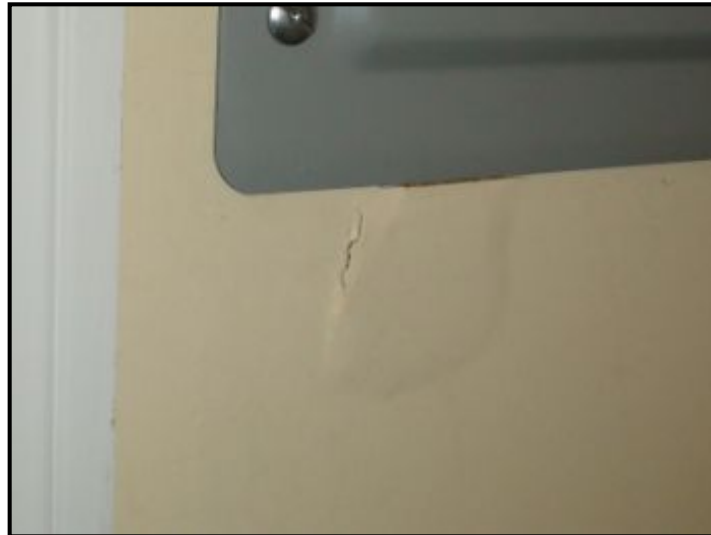
- Appeared serviceable at time of inspection
- Some areas not accessible due to stored personal items - inspection is limited
- Comment: there is a small damaged area below the circuit breaker box

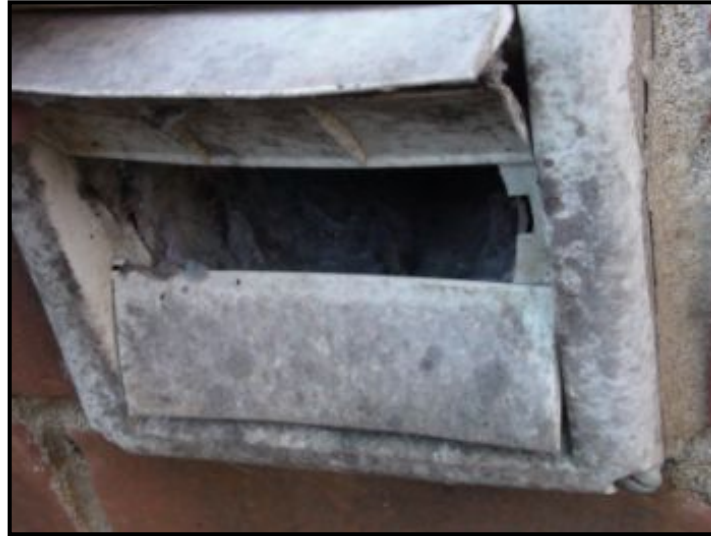
- Inspected: YES
- Dryer vent needs cleaning
- **Comment: Dryer vent installation is inefficient; it should be routed straight - without too many sharp turns. The shutters at the exterior should be removed; currently this is collecting lots of lintel within the system, which could be a fire danger.**

As a priority, I would recommend to have the dryer vent cleaned and corrected. Also, the present moisture on top of the heating system should be further investigated by an HVAC contractor.

Page 36 Item: 9	Dryer Vent	<ul style="list-style-type: none"> • Comment: Dryer vent installation is inefficient; it should be routed straight - without too many sharp turns. The shutters at the exterior should be removed; currently this is collecting lots of lintel within the system, which could be a fire danger.
-----------------	------------	--

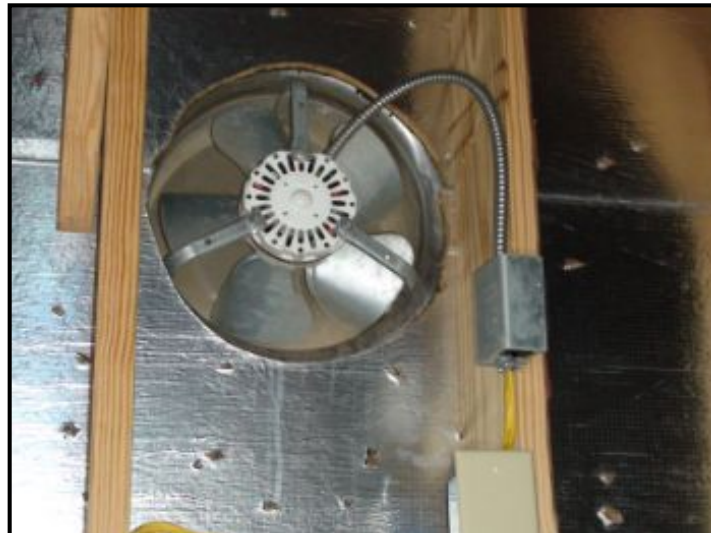
- Observations:
- Inspected: YES
 - Appeared serviceable at time of inspection
 - Gable vents
 - Soffit vents are blocked with insulation.
 - Thermostatically controlled fans are not operated.

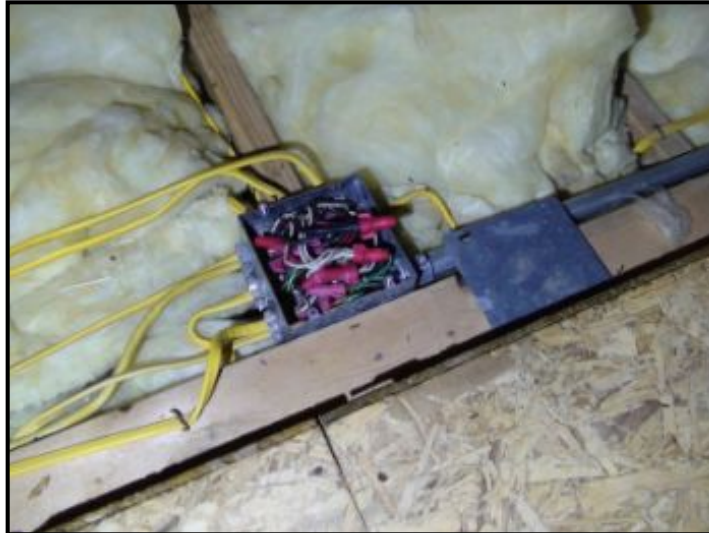
- Inspected: YES
- Appeared serviceable at time of inspection
- Electrical Box Covers missing or damaged, which is a potential shock or electrocution hazard.
- Electrical box appears to be overloaded; recommend installation of an extension or second box.

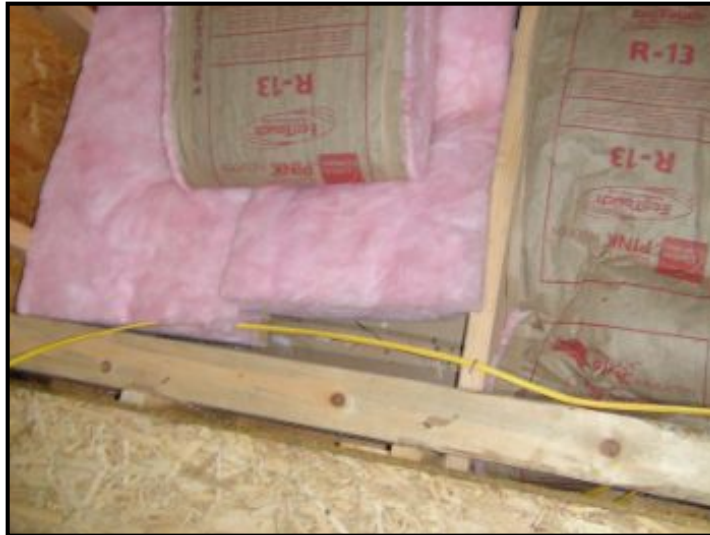
- Appeared serviceable at time of inspection
 - No insulation over attic hatch; recommend installation
 - Partially no moisture barrier installed
 - I would recommend to re-arrange some pieces of insulation to ensure that the whole area is covered. I would also recommend the installation of recessed lights that allow zero distance to combustible materials like insulation.
- This would increase energy efficiency.
- The ceiling above the garage is not insulated

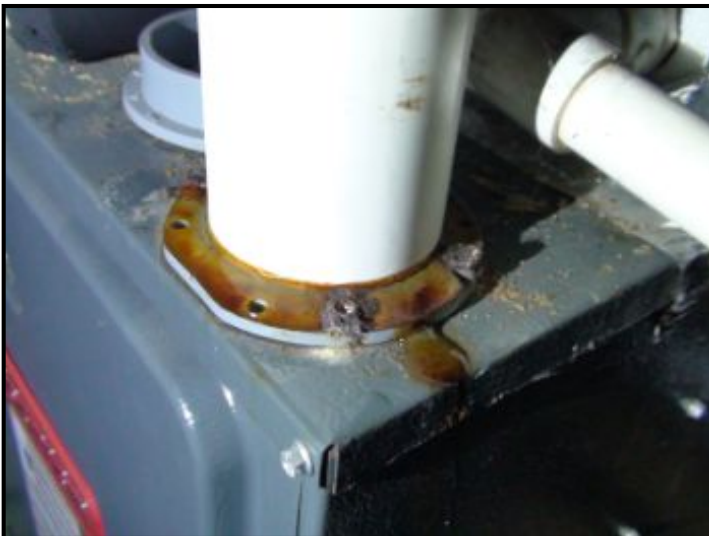
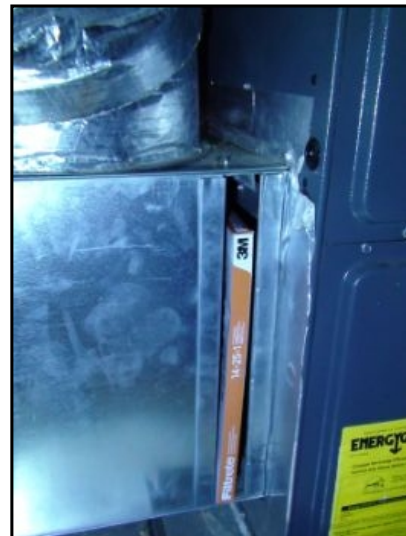
- Appeared serviceable at time of inspection
- Safety controls not tested; they are beyond the scope of a home inspection. Safety controls should be inspected by a qualified specialist.
- There is slight corrosion and water on the exhaust system present. Recommend evaluation and servicing.
- The installed air filter should be exchanged to a low performance air filter and the correct size. Currently a large volume of the air bypasses the filter.
- There is a similar additional gas furnace next to heating system A installed, Model CAPF1824BCCA, Serial # 0711027922 - all comments above apply to it too.

The model and serial numbers stated are from the cabinet of the heat exchanger, no other model numbers were visible or available.

- Cabinet fronts sealed with mastic; not opened

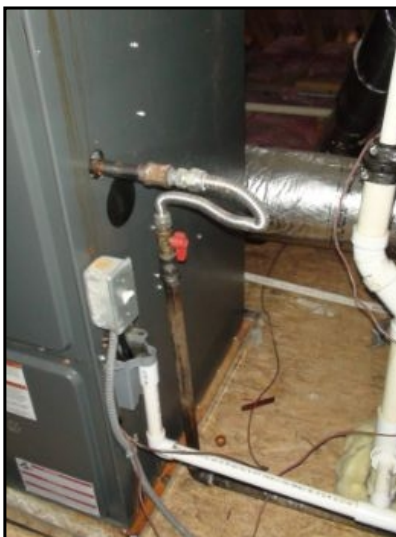
- Forced Air
- Up-flow
- Heat exchanger not fully visible, not part of this inspection
- Thermostat located at rooms
- Inspected + Tested: YES
- Appeared functional at time of inspection
- Safety controls not tested
- At Unit A is some moisture present on top of the cabinet around the vent pipe. This can be a sign of a venting issue; I recommend servicing the unit. In the gas line of both units should be a drip leg for removal of moisture installed; the correct location would be after shut off valve.
- In the gas line of both units should be a drip leg for removal of moisture installed; the correct location would be after shut off valve.

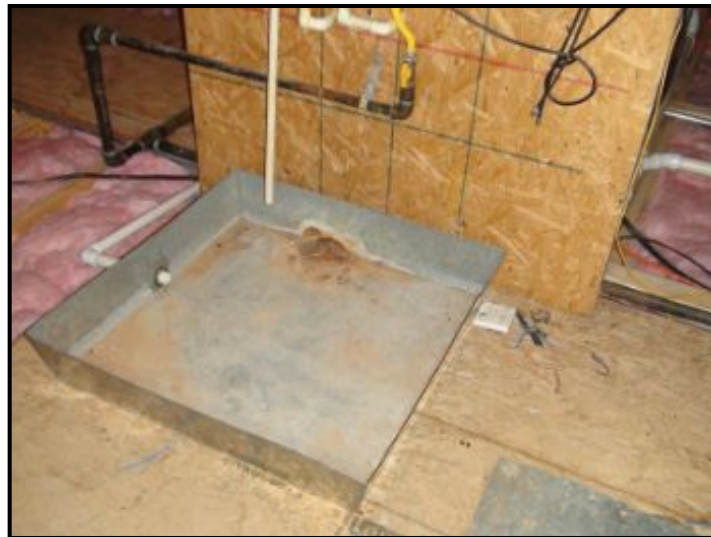
- FVIR rated: NO
- Expansion tank present NO
- Water heater was operational at time of inspection
- Discharge pipe smaller than TPR outlet
- Catch pan shows erosion and should be exchanged

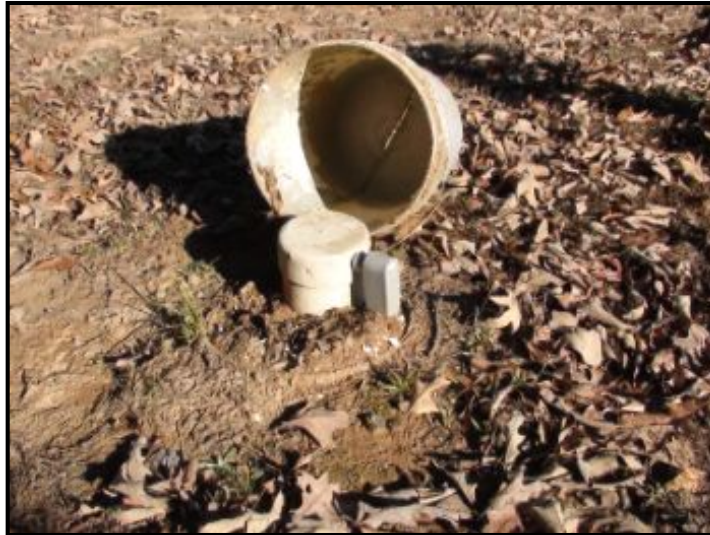
- The water well is located on the North side. Currently it's marked with a white bucket on top of it.

- Pumping, piping and electric system is installed underground and not visible for inspection
- The well number is: D0083856
- I would recommend to have a little more decorative protection for the well head installed.
